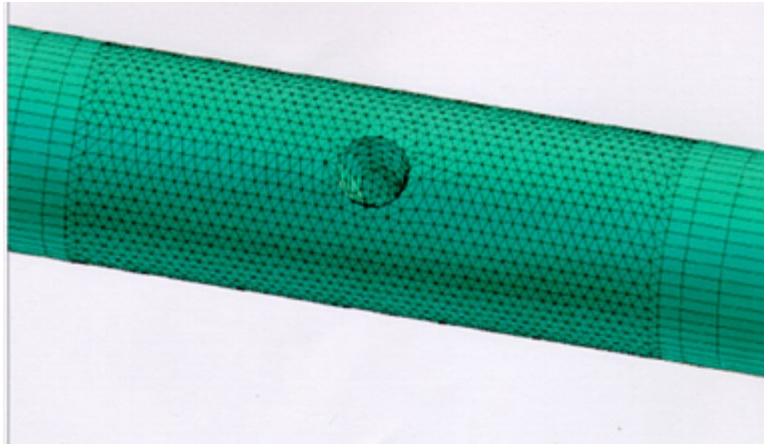
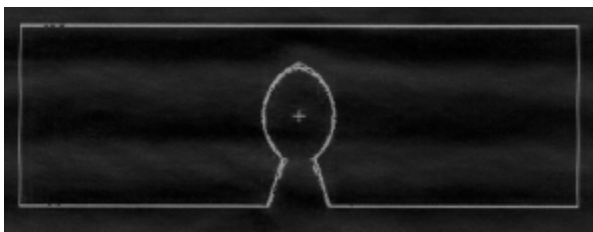
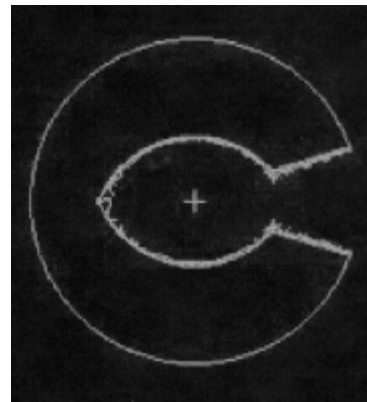
Figure 24 Model of “Rocket Engine” Defect

The shape of the cup in the cladding area reflects the speed at which the reaction occurs in the pure silica material and its increasing speed in the Ge rich material. A FEA model was constructed for the BF04515 fiber to understand the internal stresses in the glass with a “rocket engine” defect when the fiber is under a 25% strain (Figure 24a through c). Figure 25a through c shows that the internal stress in the fiber in this case rises by a factor of three over a section, which is experiencing the same amount of strain with no “rocket-engine” defect.

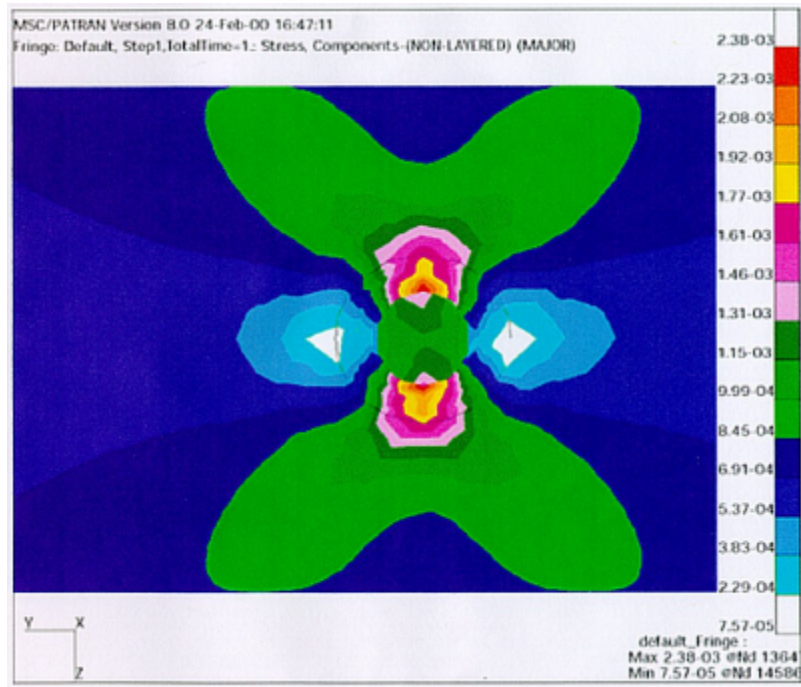
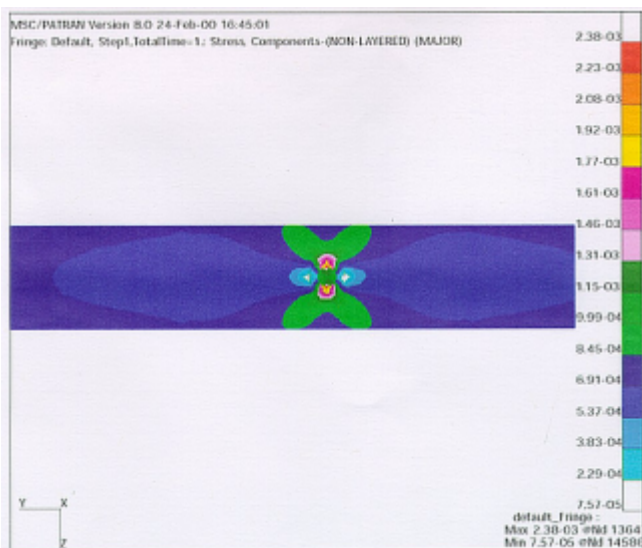
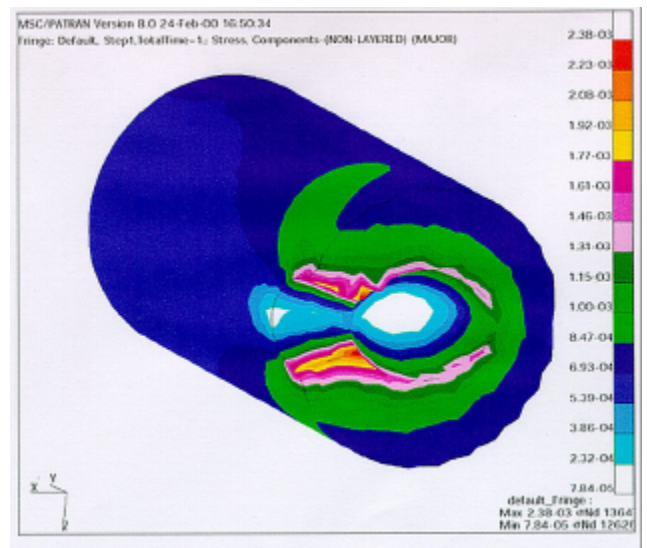
Figure 25 Stress Predicted by Fiber Model

a. Stress in Flawed Fiber Under 25% Strain (view from top looking down into the hole)

b. Top View of Stress Model

c. 45° Cutaway View of Stress Model

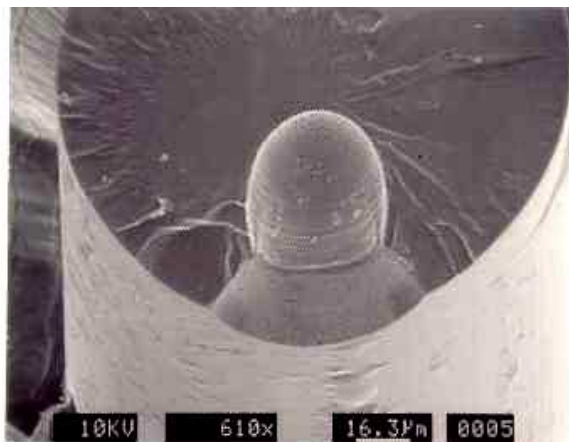
Figure 26 Etch Pit Resulting From Experimentation

Lucent Technologies experimented with BF04515 fiber from a cable with “glows”. The polyimide coating was stripped and the grounded, carbon coated fiber was exposed to a 1 kV source (wire electrode). An arc discharged through the air between the wire and the fiber. The sample was then exposed to both aqueous and vapor HF (in a humid environment) [ref-16]. HeNe light was transmitted through the fiber during the test and when light began to leak out of the side, the test was stopped. Figure 26 shows the resulting defect with the characteristic bulb pattern and ringed structure seen in the Boeing photographs (Figures 9). The sample was rinsed to drive off the highly corrosive HF, so it is not known whether there were any GeO₂ crystals or SiO₂ balls resulting from the experiment.

Lucent observed that the Ge-doped core etches considerably faster than the cladding. If the etch time is too long, then the entire core can be removed, leaving a silica tube with a pinhole in it. This indicates that the amount of HF present at the site is the limiting factor in the degree of etching.

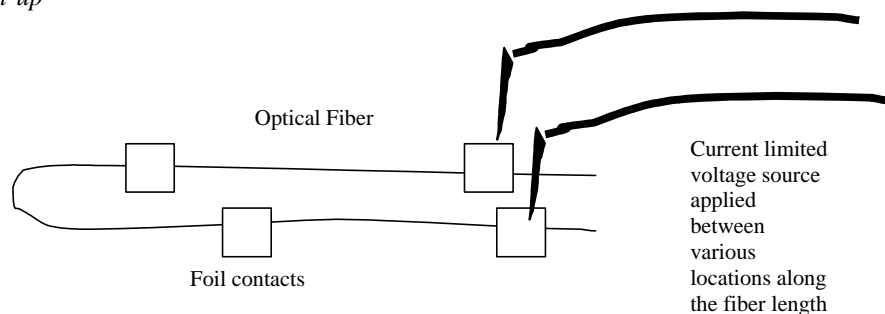
a. GSFC Set-up

NASA GSFC performed a test using the set-up shown in Figure 27a to measure the breakdown strength of a sample of fiber with known flaws. The electrodes were applied between various sets of foil contacts. A breakdown strength of 2.5 kV was measured and a burn mark resulted. The burn mark was found very close to polyimide bubbles (Figure 23).

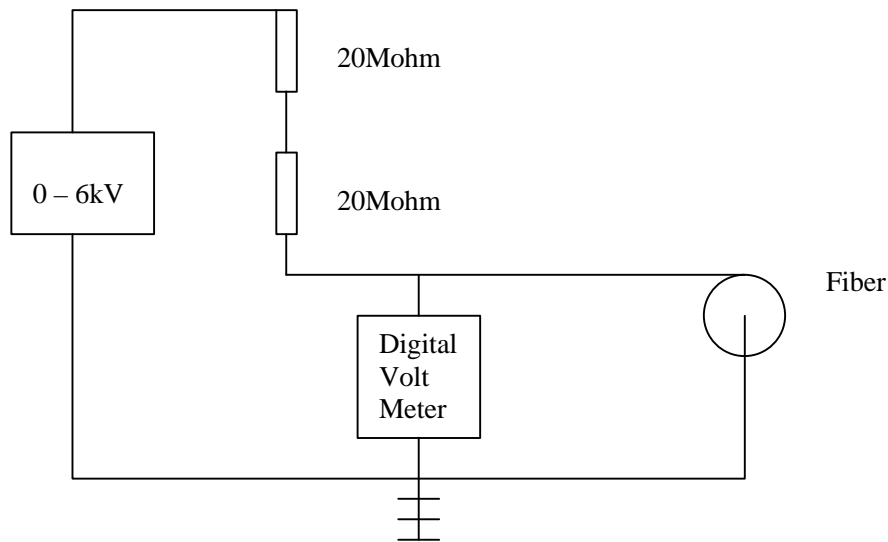
b. Aerospace Corporation Set-up

The Aerospace Corporation used the set-up shown in Figure 27b with an associated burn mark shown in Figure 22. The Aerospace Corporation found abrupt breakdown at 3.9kV in a 50% relative humidity environment, indicating a 6.5 kV/mil dielectric strength. Burn marks were found with a variety of sizes the smallest being 30 μm in diameter. They also measured the resistance of the carbon coating for lengths between 1 and 34 cm to be approximately 15 kOhm/cm, which agrees with Lucent-SFT’s databook value.

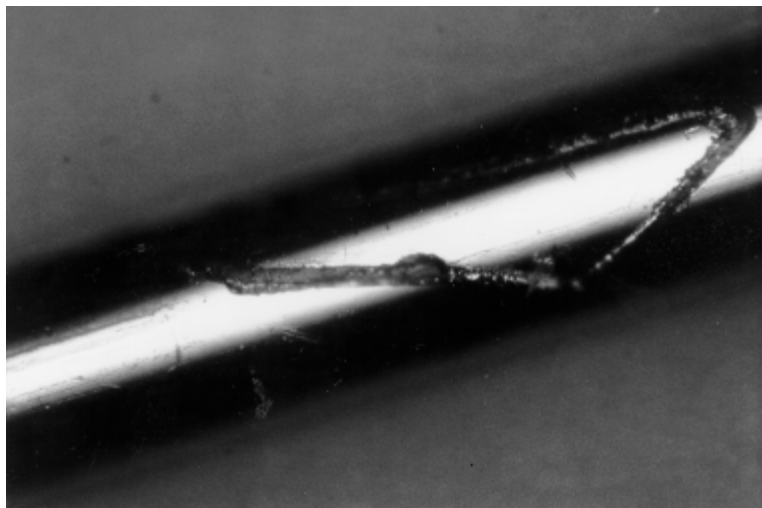
Figure 28 Electrical Discharge Induced Damage on Fiber Surface

Testing was also done with a 30 kV Tesla coil to demonstrate the conducting behavior of the NFOC-2FFF-1GRP-1 cable. When the Tesla coil tip was placed about a centimeter from the cable, the tip of the coil emitted a spark that was drawn to the cable. This spark was drawn along as the tip of the coil was moved along the cable. Upon removal of the fiber from the cable sample, the trench shown in Figure 28 was observed. Though it is not obvious in the photograph, particles believed to be polyimide surround the blackened edges of the trench suggesting that all of the polyimide did not vaporize and some of it was redeposited around the site near the trench. This demonstrated that high electric fields can cause charge travel all the way through the cable layers and damage the fiber coating.

Another run of this test was performed on 1996 vintage cable and the spark was found to “stick” to a particular site until the coil was move sufficiently far away and then the spark would move with the coil tip. This behavior was not investigated further. The wider portion of the trench seen in Figure 28 may be demonstrating the results of such a “sticking” behavior.

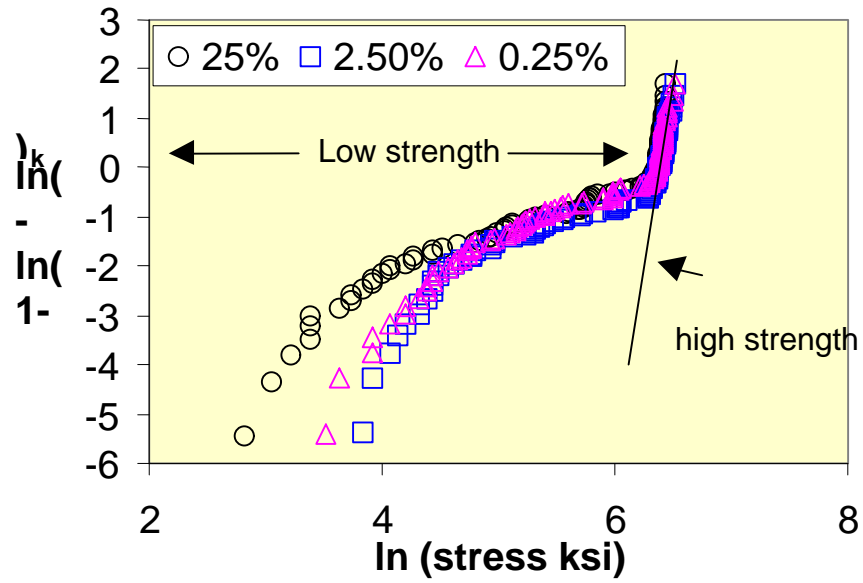
Figure 30 Weibull Plot for Strength of 1996 Vintage Cable from Several Cable Reels

The results of the initial strength tests are shown in the Weibull plots in Figures 30 and 31. Prior analysis showed that the fiber shipped by Lucent-SFT was proof tested to 141 kpsi (@ 3.36 lbs). The cable specification requirement is for a fiber strength of 200 kpsi (@ 4.76 lbs). Lindholm, et. al., report strengths of 500 kpsi (11.90 lbs) and higher for four carbon coated fibers they have manufactured. The plots showed the high strength of the cabled fiber to be around 252 kpsi (6 lbs) and the low strength to go as low as 126 kpsi (3 lbs).

The inspections found that defects were present in large numbers that were either small etch pits at the surface of the cladding or corrosion sites in the same location. The knees in the Weibull plots, an associated slopes, show that there is more than one dominant failure mode. According to the physics of glass, the order of the curves should show the black circles (highest strain rate) located to the right of the other curves, not to the left. Figure 31 shows that the distribution of low strength breaks among the reels was significantly different even for reels with the same date of manufacture. These distributions could not be used to quantify the expected life of the cable using classical methods.
